Subject:- Committee to review reconstruction work of Malabar Hill Reservoir.

Final report of the Committee for review of the Malabar Hill Reservoir.

FINAL REPORT OF THE COMMITTEE FOR REVIEW OF MALABAR HILL RESERVOIR

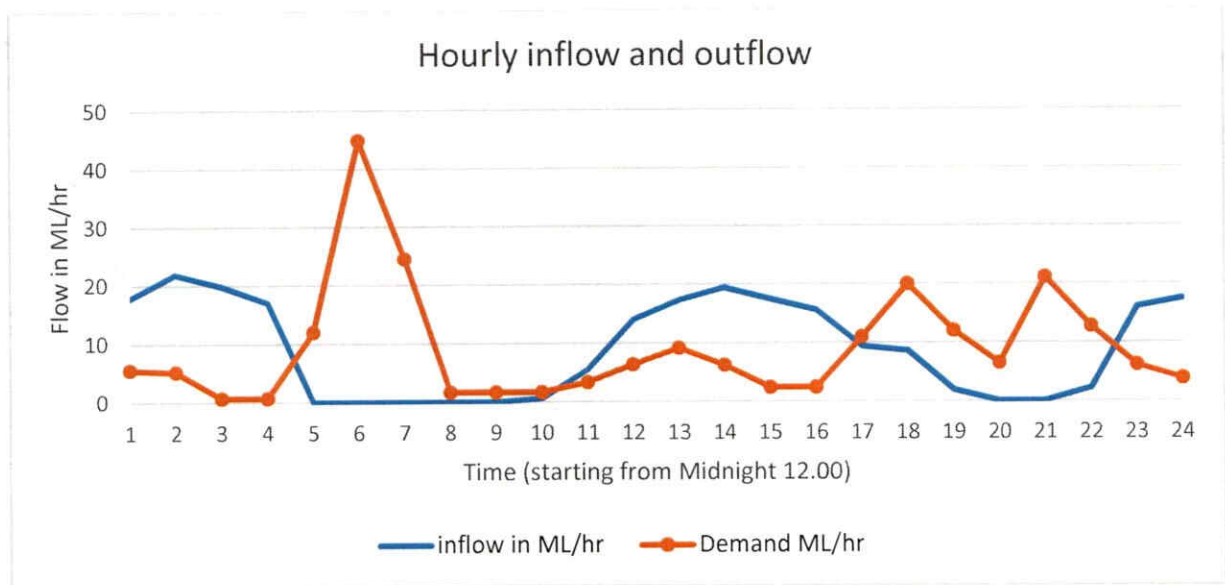
The inflow and outflow patterns of MHR based on the data given by BMC are given in Figure 5.1.

Figure 5.1. Inflow and outflow pattern of MHR (data Source: BMC)

From Figure 5.1, it is seen that the inflow pattern follows two cycles per day, starting from the previous day's night 9.00 pm to the current day 5.00 am, and then again from 10.00 am to 8.00 pm, with no inflow from 5.00 am to 10.00 am. The peak inflow is at 2.00 am and 2.00 pm during the first and second cycles, respectively.

From Figure 5.1, it can be seen that the outflow is continuous throughout the day and has two high outflow cycles: the first cycle starts from 4.00 am to 8.00 am, and the second cycle starts from 10.00 am to the next day at 3.00 am with multiple peaks. This is due to the staggered outflow operations of multiple outlets.

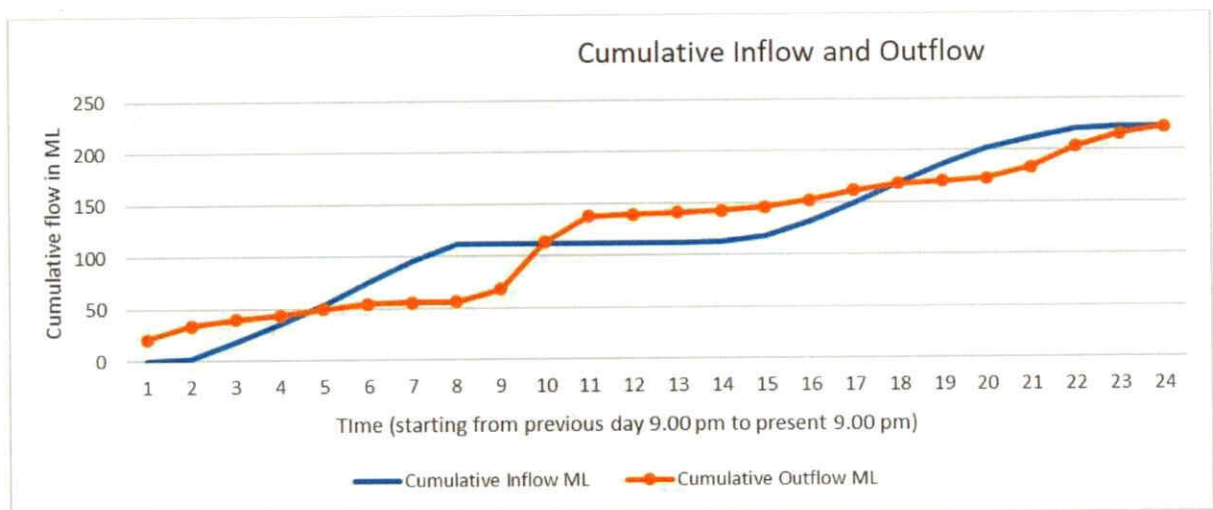
The usable storage capacity required for the present inflow and outflow patterns is estimated using the double mass curve technique as per CPHEEO (2023, Part A). The double mass curve drawn for MHR with an operational period of one day (i.e., the operational inflow-outflow cycle repeats every 24 hours), is given in Figure 5.2. From Figure 5.2, the maximum surplus in a day and the maximum deficit in a day account for the required usable storage of MHR. Based on the CPHEEO recommendations, the required usable storage of MHR for the given inflow and outflow patterns is given in Table 5.1.

Figure 5.2. The mass curve of cumulative inflow and outflow of MHR
